Brookfield Historic Inventory Update

City of Brookfield, Wisconsin
December 2008
Printed May 1, 2009

Prepared by:
Eric Ponto

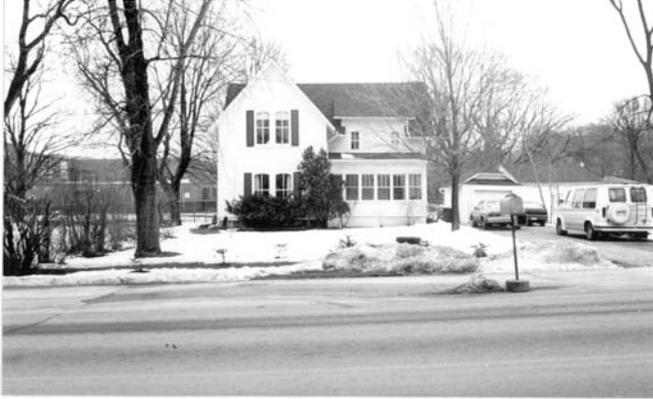
The Hoff House (2500 N. Brookfield Road) was demolished in 2000

Several structures have been demolished due to expansion, such as the residence at 2500N. Brookfield Road and some are threatened by future development, such as the log home structure encapsulated by a turn of the century farmhouse at 3625 N. Calhoun.

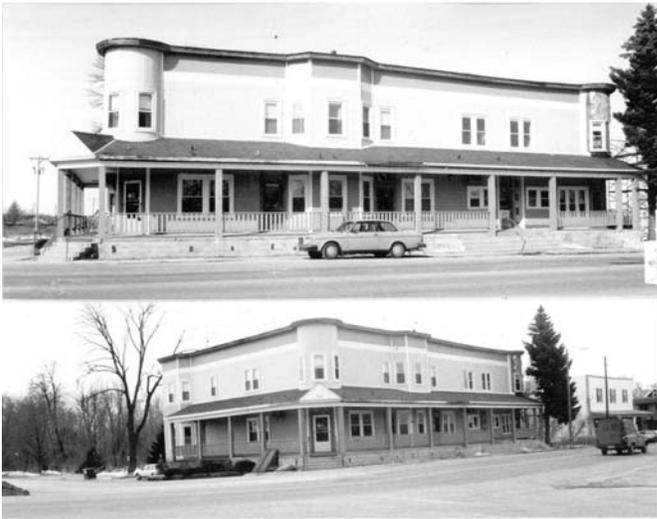
Former Plank Hotel 1993

Some commercial structures such as the former “Plank Hotel” 2849-55 N. Brookfield Road may be underutilized, which could result in delayed maintenance and threaten its future, but currently its condition has not deteriorated greatly in the intervening 16 years.

7771	036	LN	Plank Hotel, 2849-55 N. Brookfield Road (aka 2835 N. Brookfield Road), Queen Anne, 1906/Historical Society and Assessor, HSL, SHSW. 2008 Update: Moderately well maintained, no noticeable alterations.

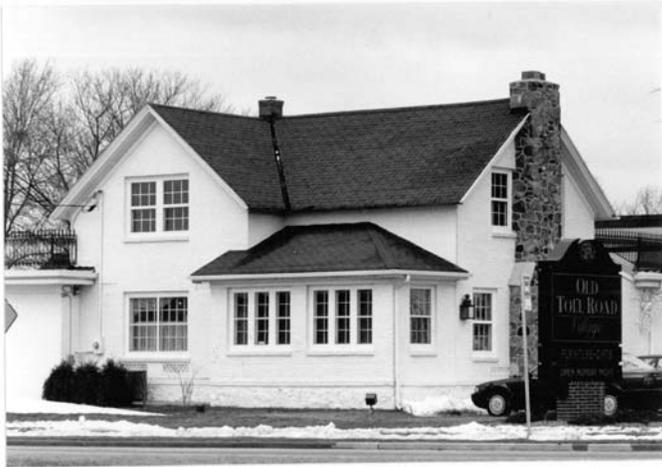
Galobinske Farm (16460 W. Bluemound Road) 1993

Others suffered from minor alterations, such as at the Galobinske Farm 16460 Bluemound Road. In this case double vertically proportioned windows replaced with one larger window at the South elevation change the scale and level of detail of the opening. Insensitive signage on the building compromises its historical character; while not dramatic changes they do affect the overall integrity of the structure.
